BAIR DAM

MANUAL FOR OPERATION AND MAINTENANCE

**State Water Projects Bureau
Water Resources Division
Department of Natural Resources and Conservation
1424 9th Avenue
P.O. Box 201601
Helena, MT 59620-1601**

**Initial Publication May 1995
Revised February 2004**

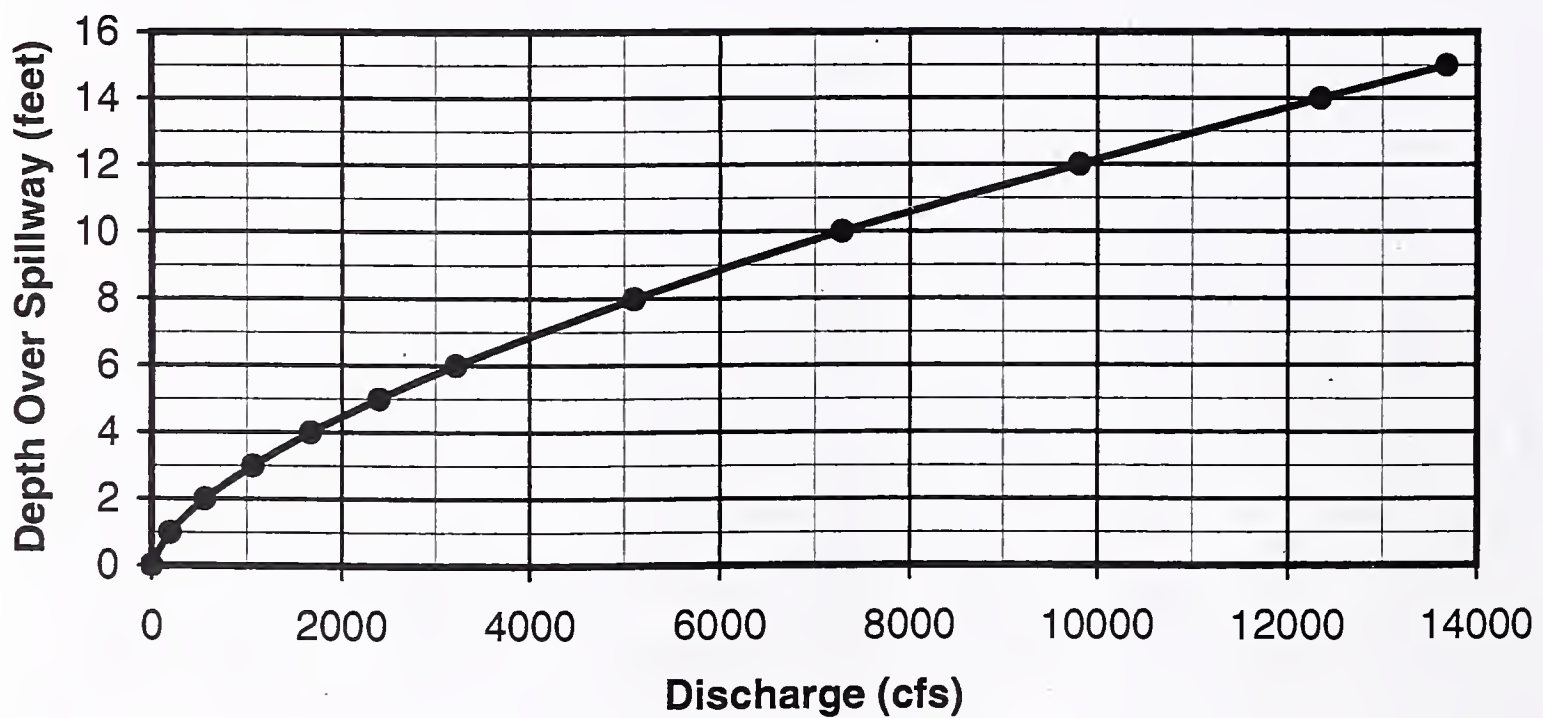
BAIR DAM SPILLWAY RATING CURVE

Depth Over Crest (feet)	Elevation (feet)	Discharge (cfs)
0	5325.0	0
1.0	5326.0	191
2.0	5327.0	558
3.0	5328.0	1063
4.0	5329.0	1670
5.0	5330.0	2392
6.0	5331.0	3215
8.0	5333.0	5100
10.0	5335.0	7281
12.0	5337.0	9807
14.0	5339.0	12345
15.0	5340.0	13677

Note: Data from Bair Dam Rehabilitation Construction Report by HKM, dated 10/2003.

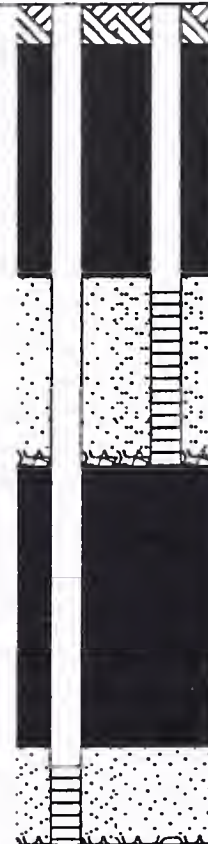
1" PVC Pipe
Typical1" PVC Pipe
Typical1" Slotted
(0.020") PVC
(47.5'-52.5')1" Slotted
(0.020") PVC
(18'-28.8')

Five drill holes in the dam embankment and one slope inclinometer in the left abutment above the spillway were installed in 1999. In 2002, three additional slope inclinometers were installed in the left abutment above the spillway. See Figure 4 for the location of the monitoring wells. Soil profiles of the drill holes and details as to how the wells were constructed are shown in Appendix D.

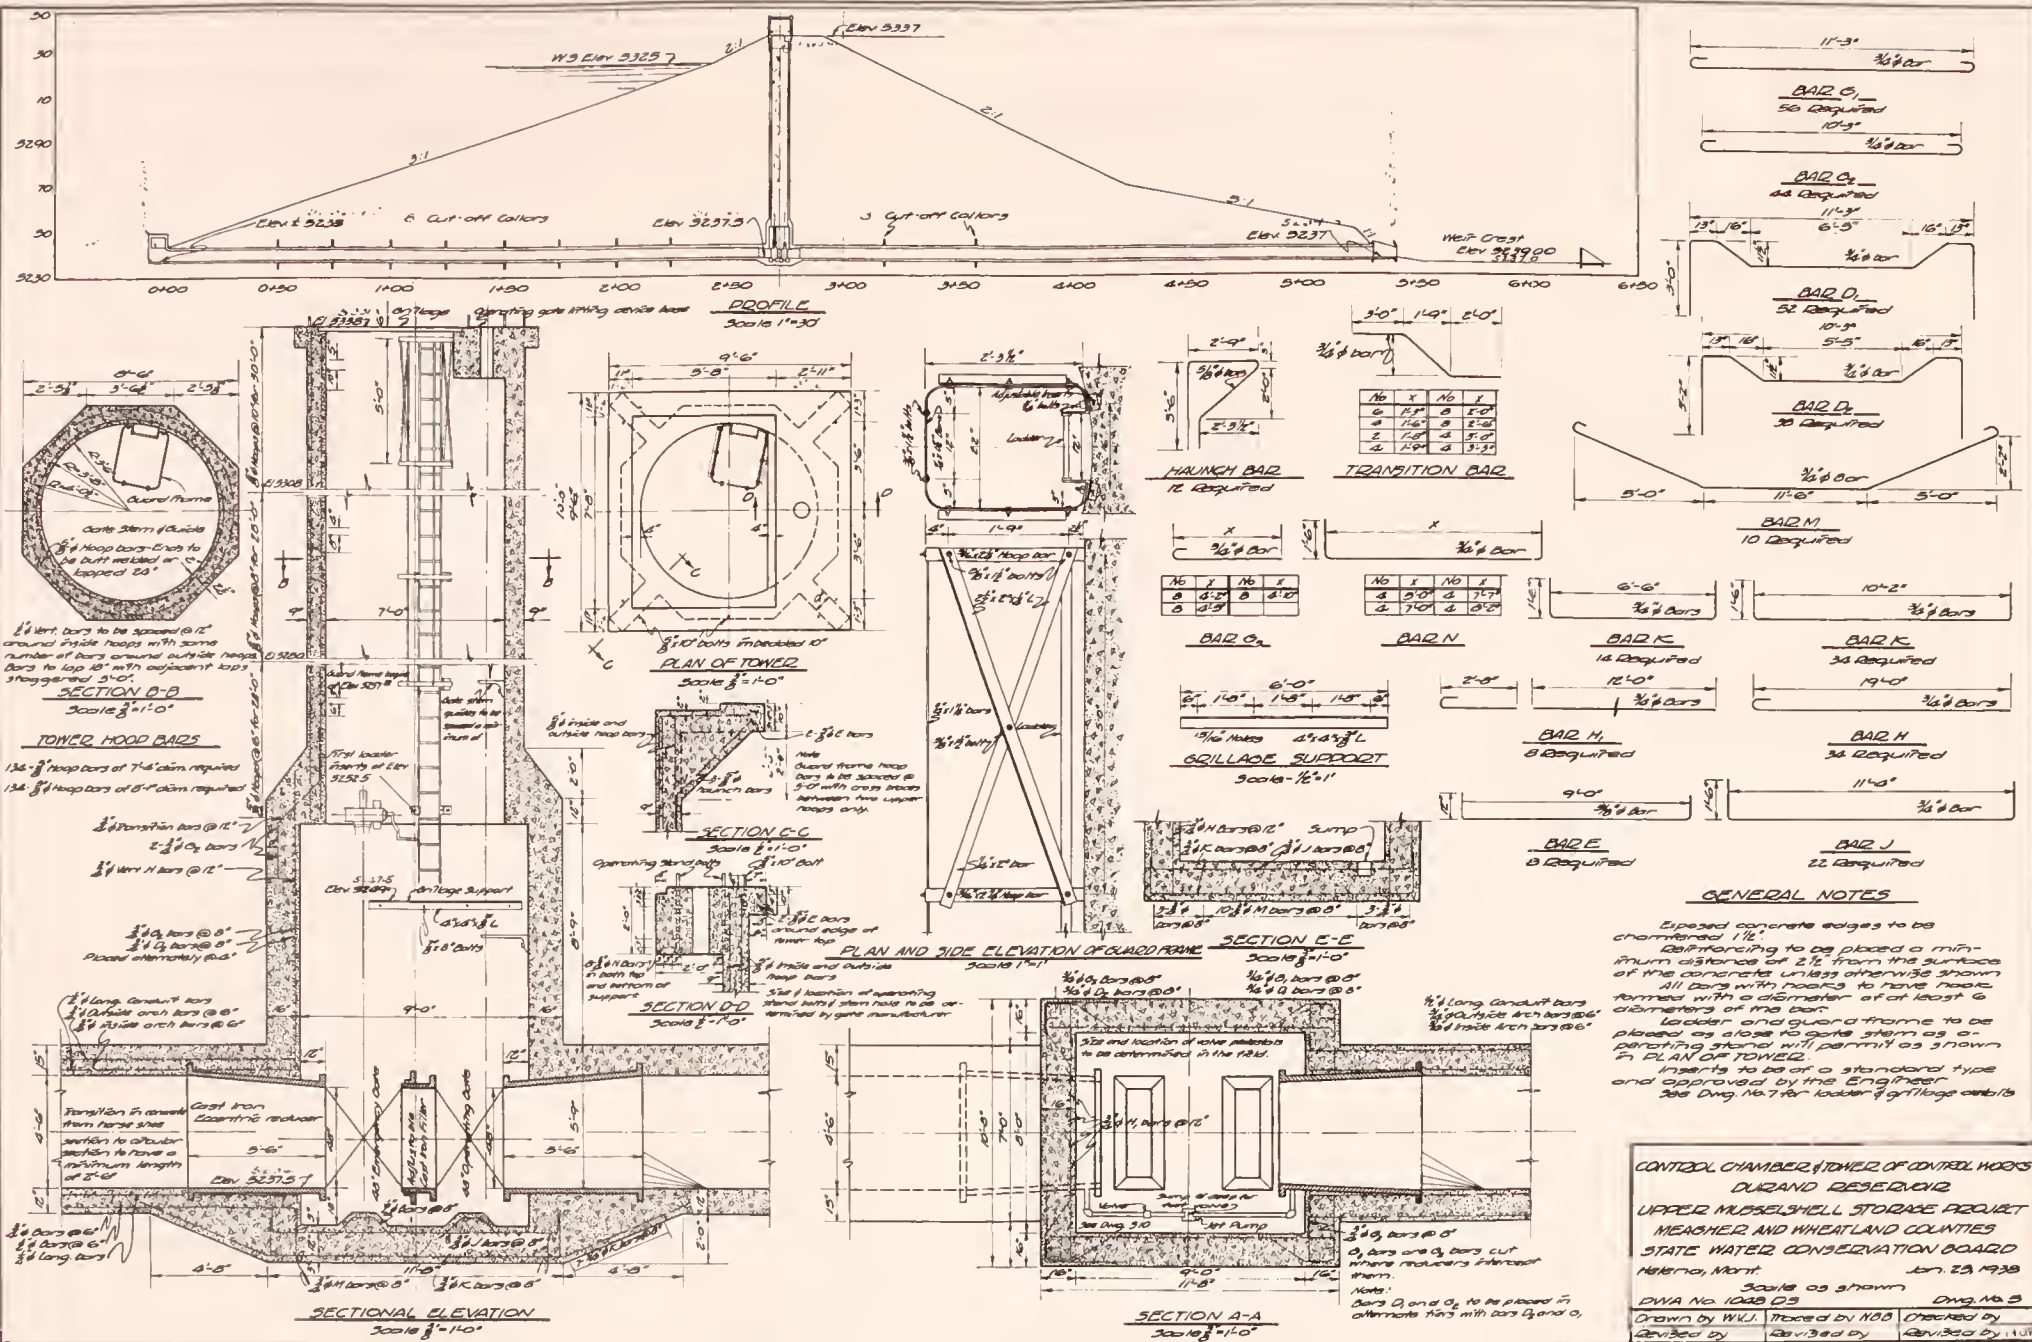
CONTROL CHAMBER & TOWER OF CONTROL WORKS
DURAND RESERVOIR
UPPER MISSOURI STORAGE PROJECT
MEADDER AND WHEATLAND COUNTIES
STATE WATER CONSERVATION BOARD
MELROSE, MONT. Jan. 23, 1938

Scale as shown
DWA No. 1008 DS Dwg. No. 3
Drawn by W.K.L. Checked by H.B.B. Checked by J.W.L.
Revised by

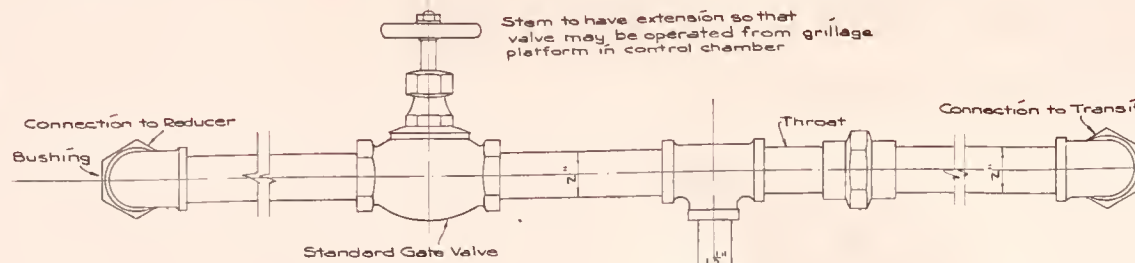
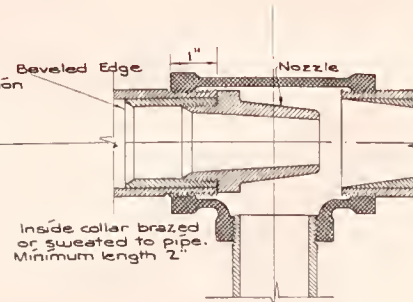
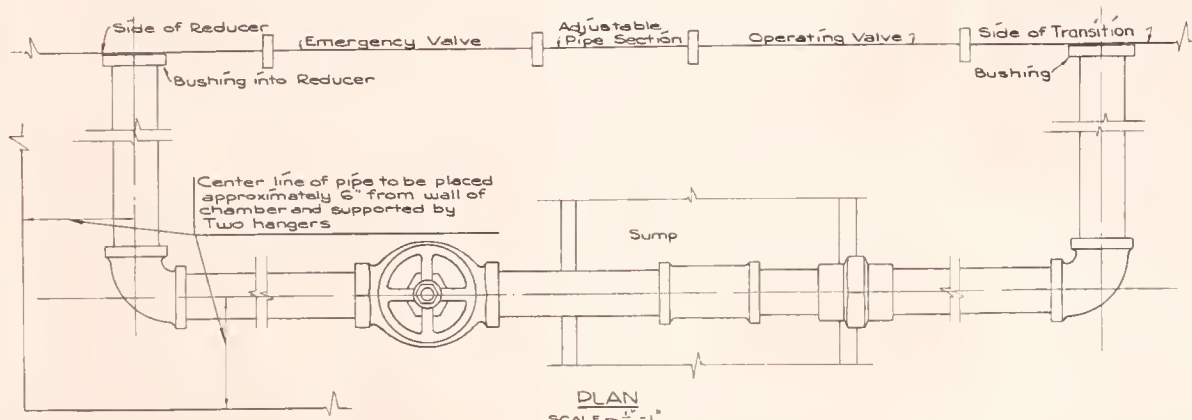
STANDARD JET PUMP

Note:
Pipe and all fittings to be extra strong galvanized.
Sump to be located in chamber as directed by the engineer.

ELEVATION
SCALE $\sim \frac{1}{4}'' = 1''$

SECTION THROUGH TEE
SCALE $\sim \frac{1}{2}'' = 1''$

NOZZLE DETAIL
SCALE $\sim \frac{1}{2}'' = 1''$

PLAN
SCALE $\sim \frac{1}{4}'' = 1''$

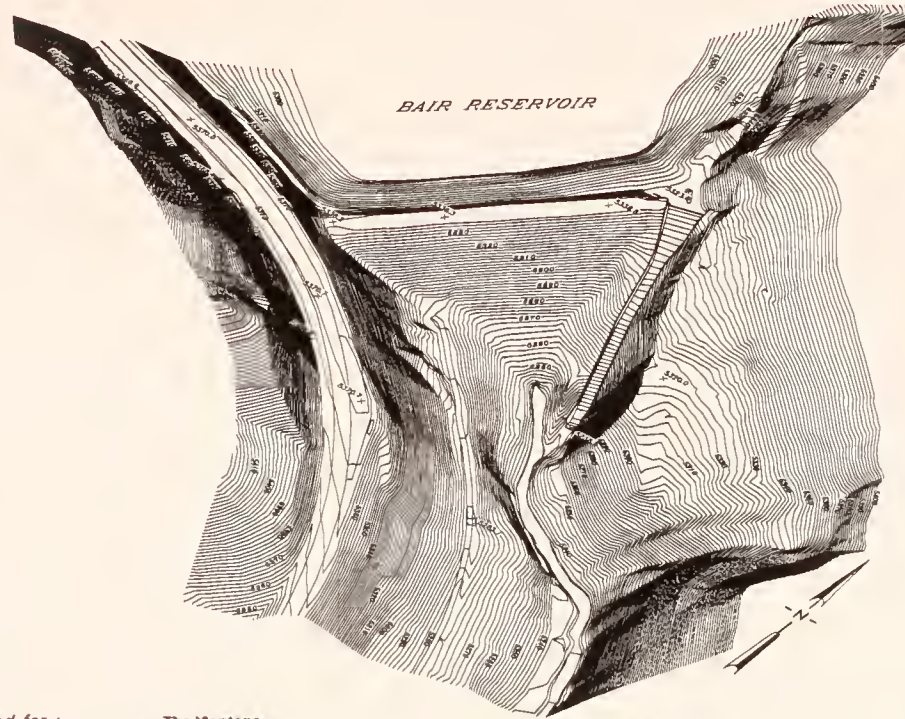
PERSPECTIVE VIEW

BAIR DAM REHABILITATION PROJECT - PHASE 1

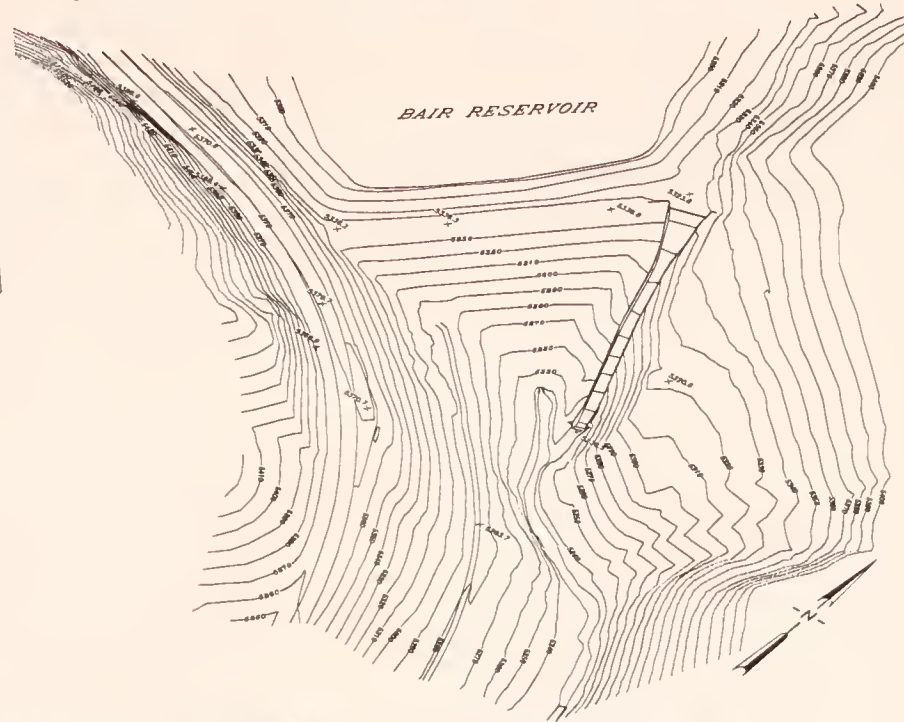
PERSPECTIVE VIEW

BAIR DAM REHABILITATION PROJECT - PHASE II MEAGHER COUNTY, MONTANA

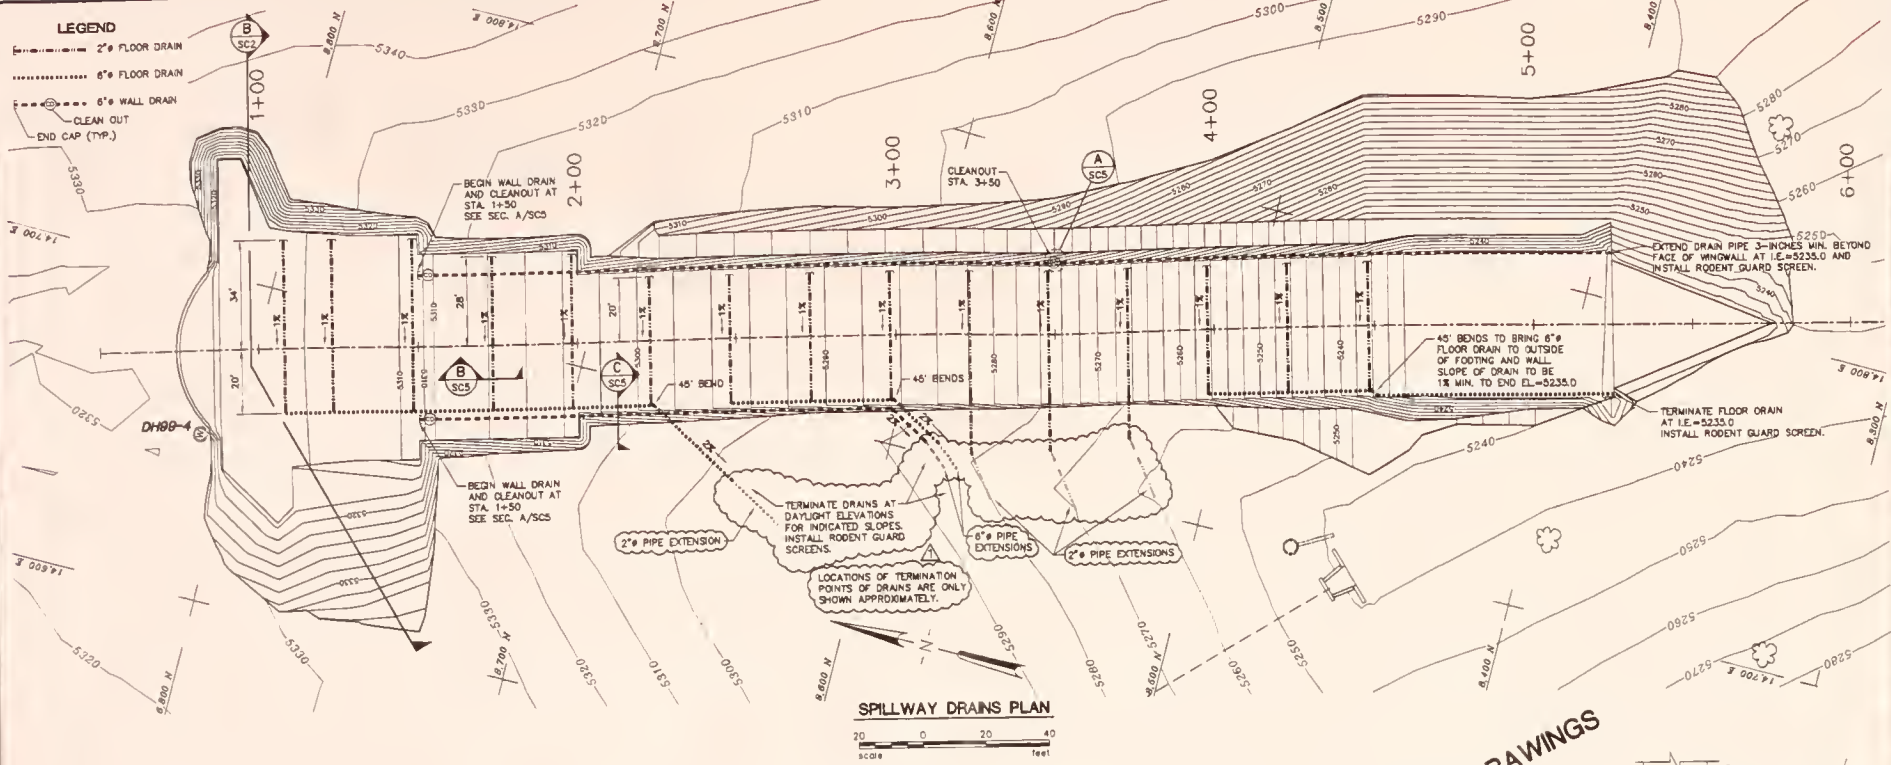
SPILLWAY DRAINS PLAN

- 2" FLOOR DRAIN
- 6" FLOOR DRAIN
- 6" WALL DRAIN
- CLEAN OUT
- END CAP (TYP.)

Also a drainage system was added beneath the new concrete spillway with six outlets which day-light to the right of the spillway and two outlets which day-light through the flip-bucket wing walls. Refer to drawing SC5 in Appendix G.

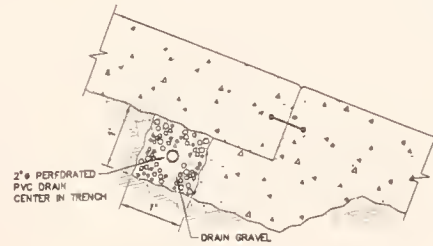
B SECTION
SC5 FLOOR DRAIN AT JOINT
1 0 1 2
feet

NOTE: ALL DRAIN PIPE TO BE NEW, PERFORATED RIGID POLYVINYL CHLORIDE (PVC) PIPE, SCHEDULE 80 CONFORMING TO ASTM D1785. ALL JOINTS TO BE GULDED. PERFORATIONS TO BE THREE LONGITUDINAL ROWS OF 1/4-INCH HOLES SPACED EVERY 2 INCHES. EQUIVALENT SLOTTED PIPE MAY BE SUBSTITUTED.

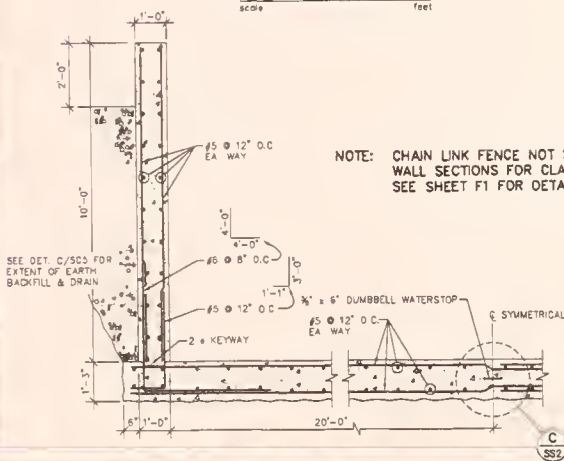
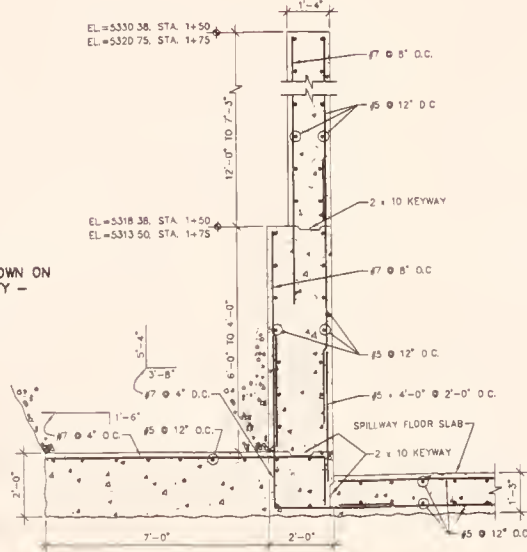
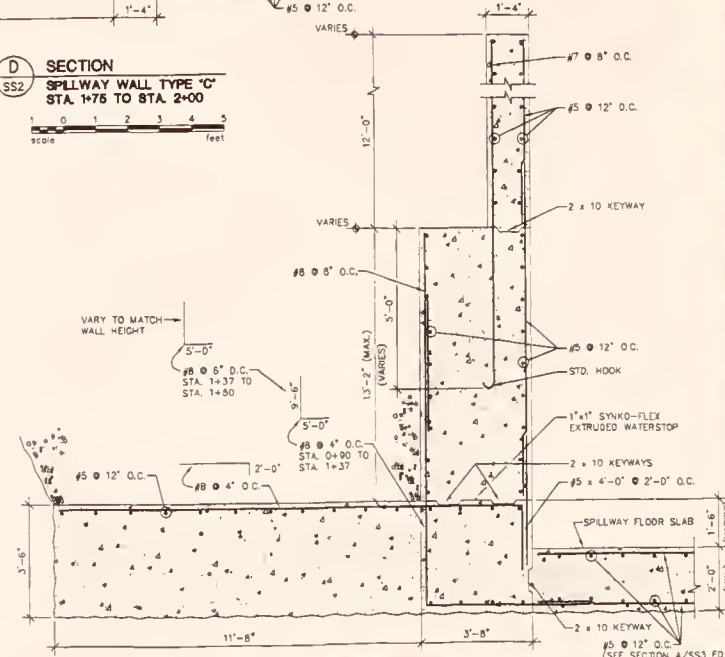
NOTE: CHAIN LINK FENCE NOT SHOWN ON WALL SECTIONS FOR CLARITY - SEE SHEET F1 FOR DETAILS
